**HIGHLAND FLATS TREE FARM
WETLAND AND RIPARIAN MITIGATION
-2017 ANNUAL REPORT-**

**Essential Oil Research Farm, LLC
Naples, Idaho 83847**

**EcoWest Consulting, Inc.
Baker, Oregon 97814**

December 2017

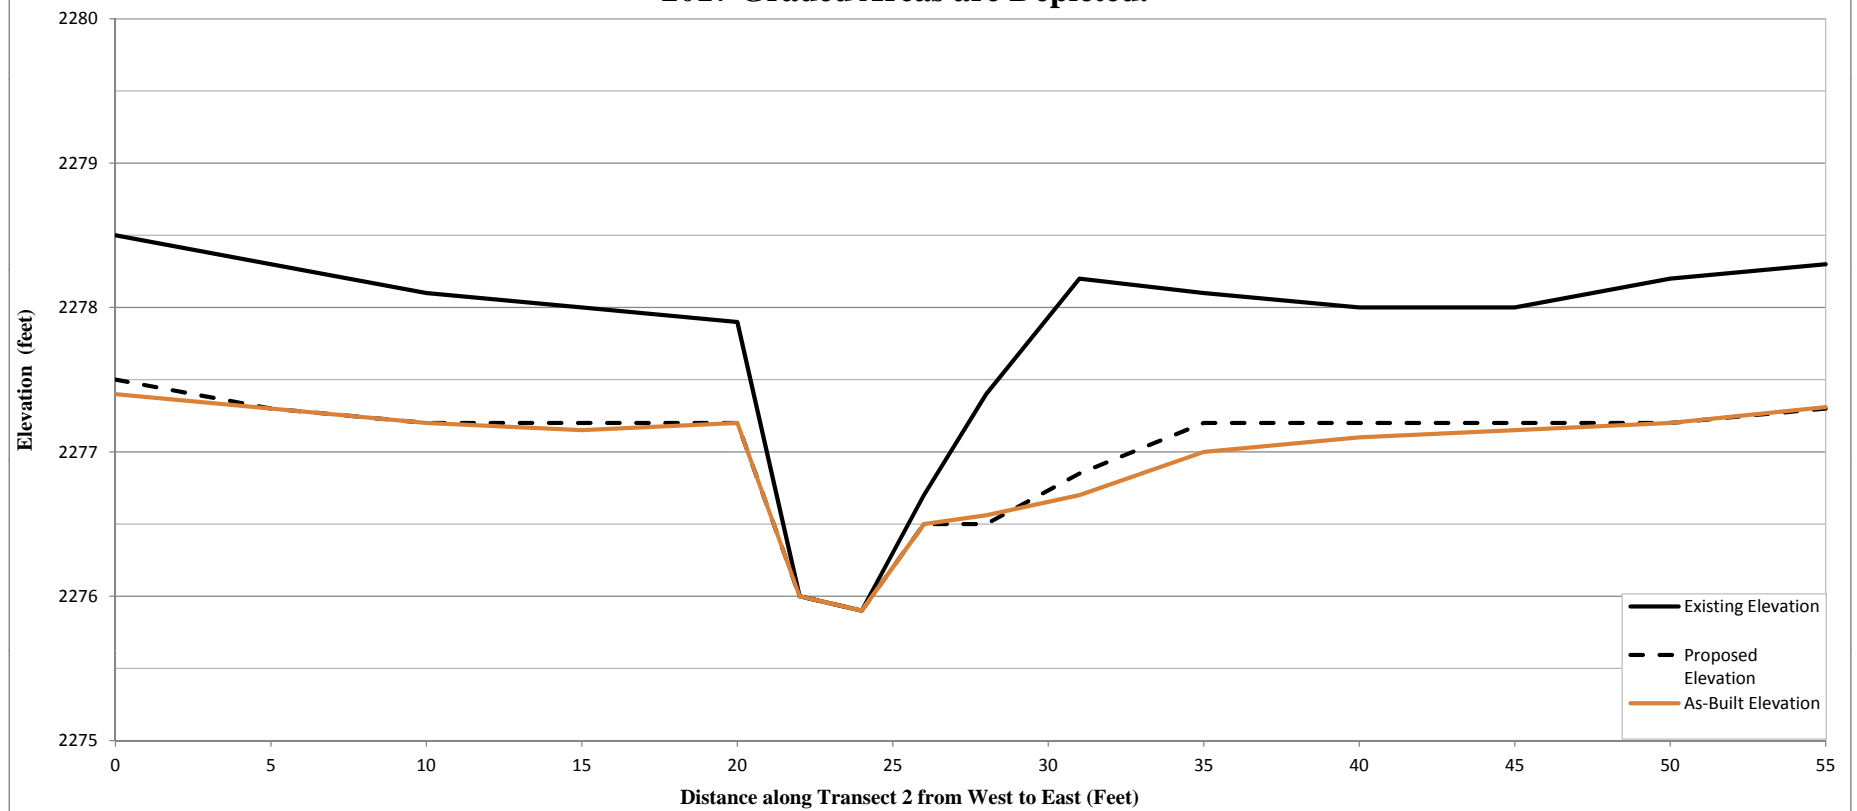
Figure 2. Baseline, Proposed and As-Built Elevations Along Transect 2 in HW-2. Both 2016 and 2017 Graded Areas are Depicted.

Grading and Topsoil Replacement. The remaining HW-2 grading and subsoil decompaction (i.e., between Transect 2 and the northern end of HW-2) occurred on August 27 and 28. Grading on the west side of the channel was conducted around existing trees and large shrubs in a manner to preserve these native plants (see photo documentation in Appendix B, Figures B-1 and B-2). Where possible, transplantation of pre-existing small meadowsweet was also conducted to retain these plants.

The new topsoil was placed on August 29. New topsoil depths were a minimum of six inches, with some scattered pockets of up to 12 inches. Overall the soil was left slightly uneven and roughened, as desired, for good soil-seed contact.

- To obtain the desired decompaction level, in lieu of making a small sharp bench adjacent to the stream channel, a more gradual slope needed to be created, similar to the slopes within the adjacent upper HW-3a. The channel tie-in point remained the same (see Figure 2).
- A trackhoe was used to both rip the subsoil and place the new topsoil within the graded area instead of a rubber tired loader. As described in the 2016 Annual Report (ECW 2016b), this equipment substitution was more effective in providing the desired end results.

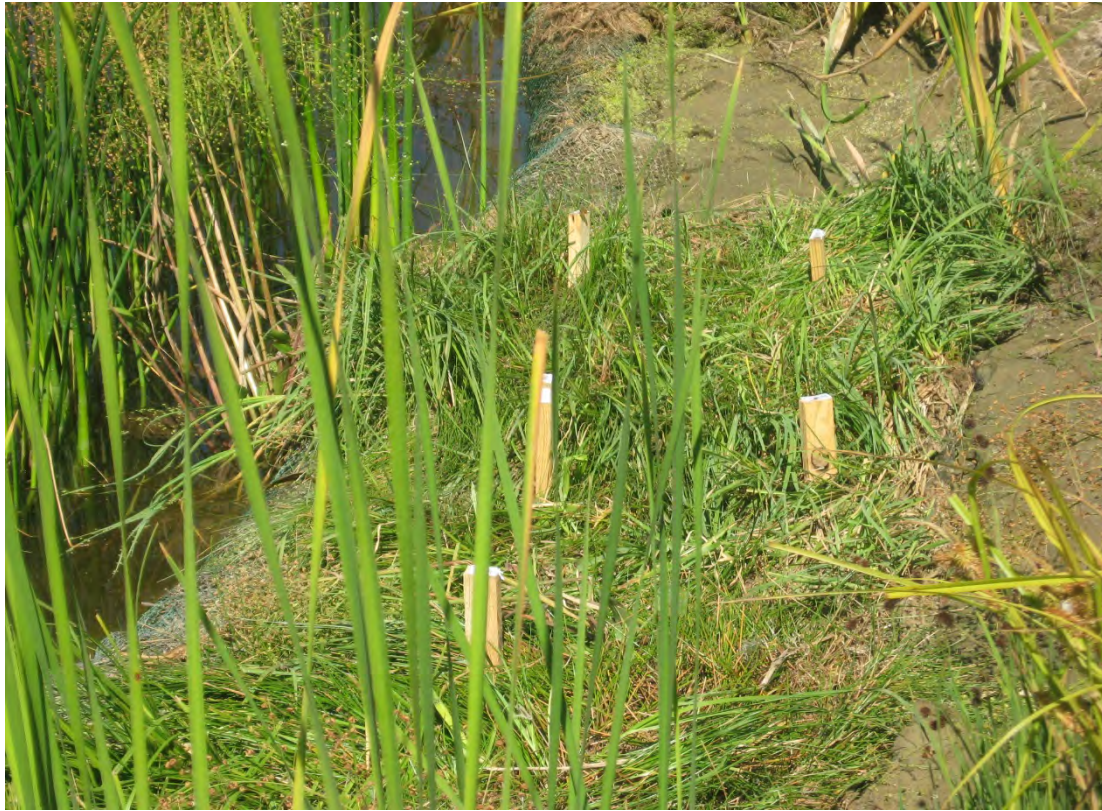
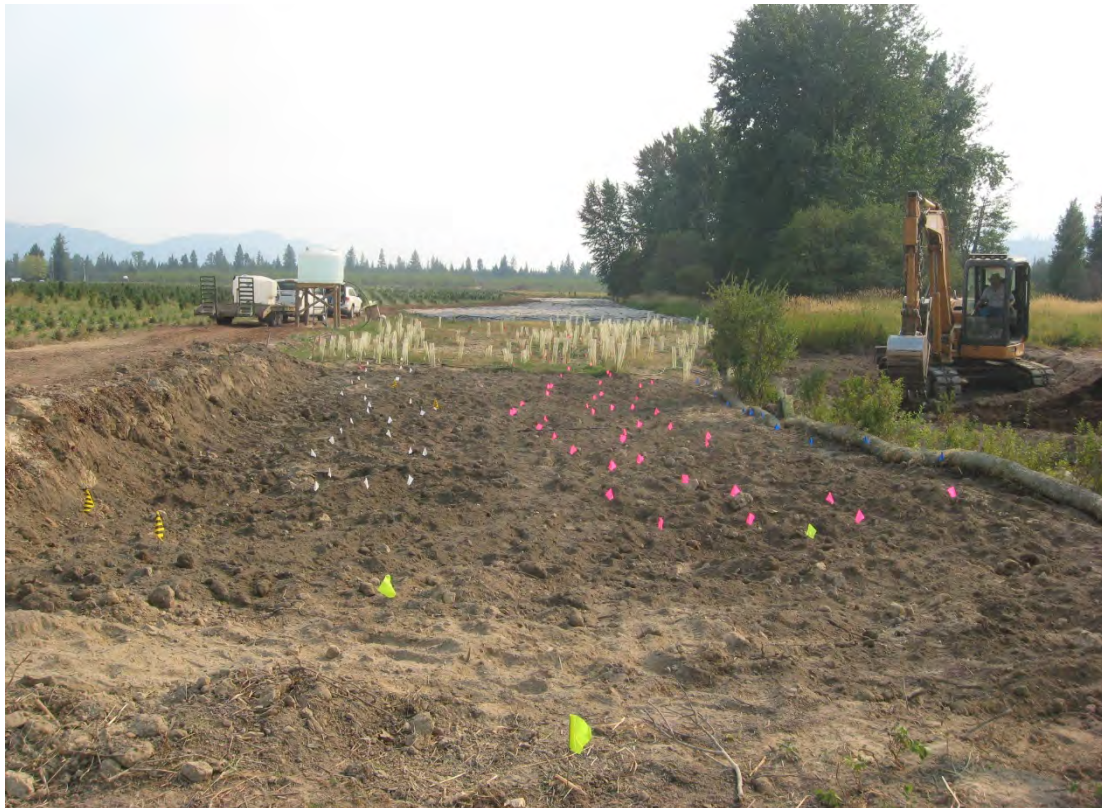
Figure B-1. Sedge sod along the Reservoir east bank immediately post installation (top) and HW-2, eastern portion post grading and with planting locations flagged (bottom). In the bottom photo, the in-progress grading of HW-2 west is also shown.

The sod mats were harvested and picked up at the grower’s facility in Rexburg, Idaho by HF staff on Wednesday, August 16. They were installed the next day (August 17, see Appendix B, Figure B-1).

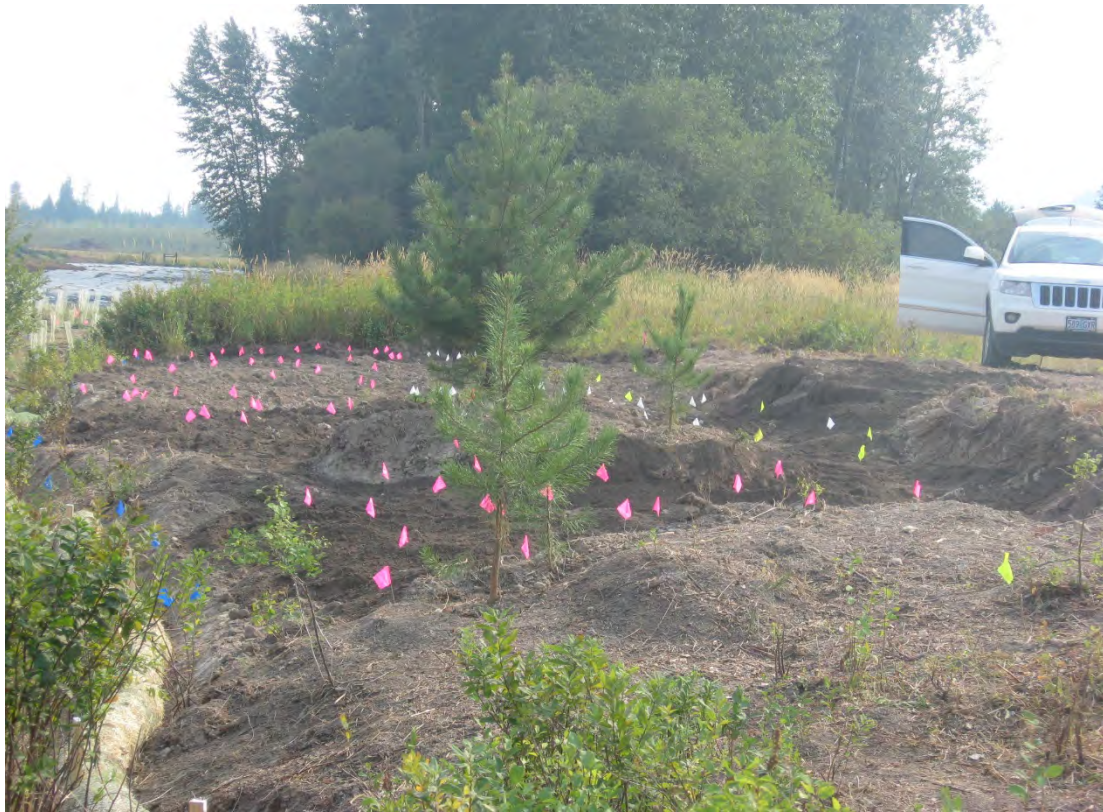
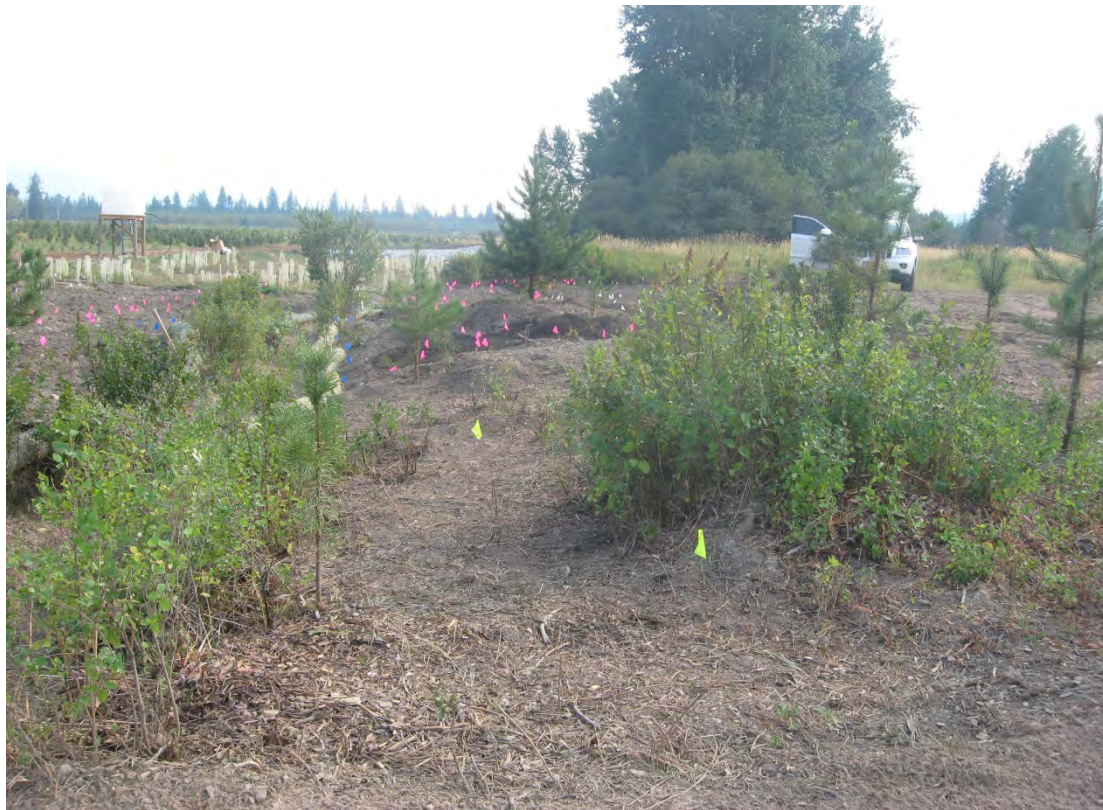
Figure B-2. HW-2 west of channel post grading showing retention of existing native trees and shrubs.

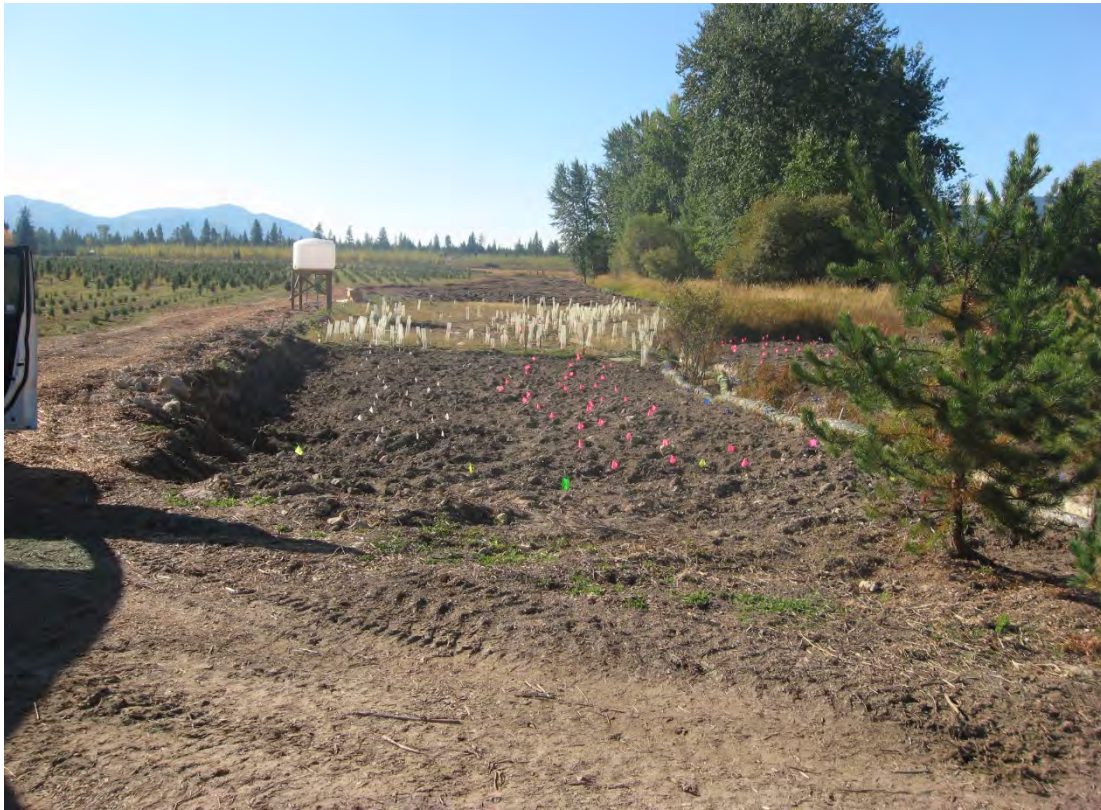
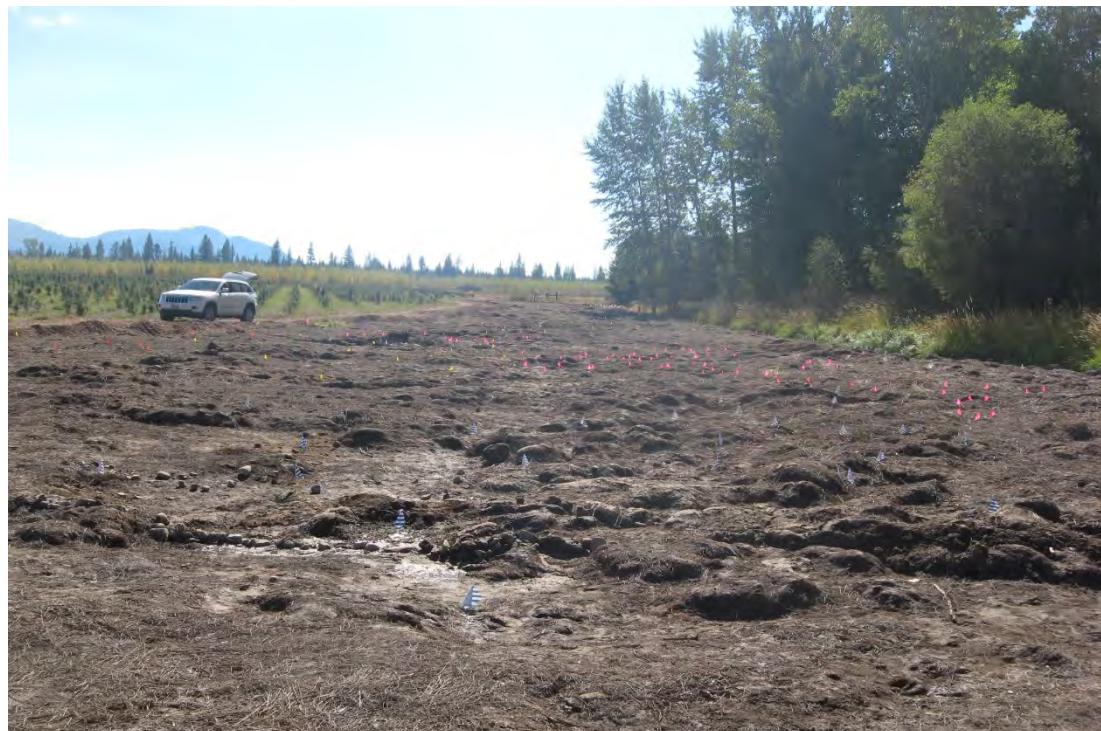
Figure B-3. Looking south at the 2017-graded portion of HW-2, the 2016-graded portion of HW-2/upper 3a, and the remaining HW area following solarization material removal, respectively (top). The bottom photo depicts part of the plant location flagging with the FACW Bebb's willow (blue and white-striped flags, foreground) placed around the depressions and stream channel, and the FAC cottonwood (yellow flags) and hawthorne (orange flags) placed in slightly higher locations.

The black plastic solarization material in the remaining portion of HW-3a and HW-3b was removed on September 23 and the plant locations flagged in preparation for planting (see photo-documentation in Appendix B, Figure B-3).

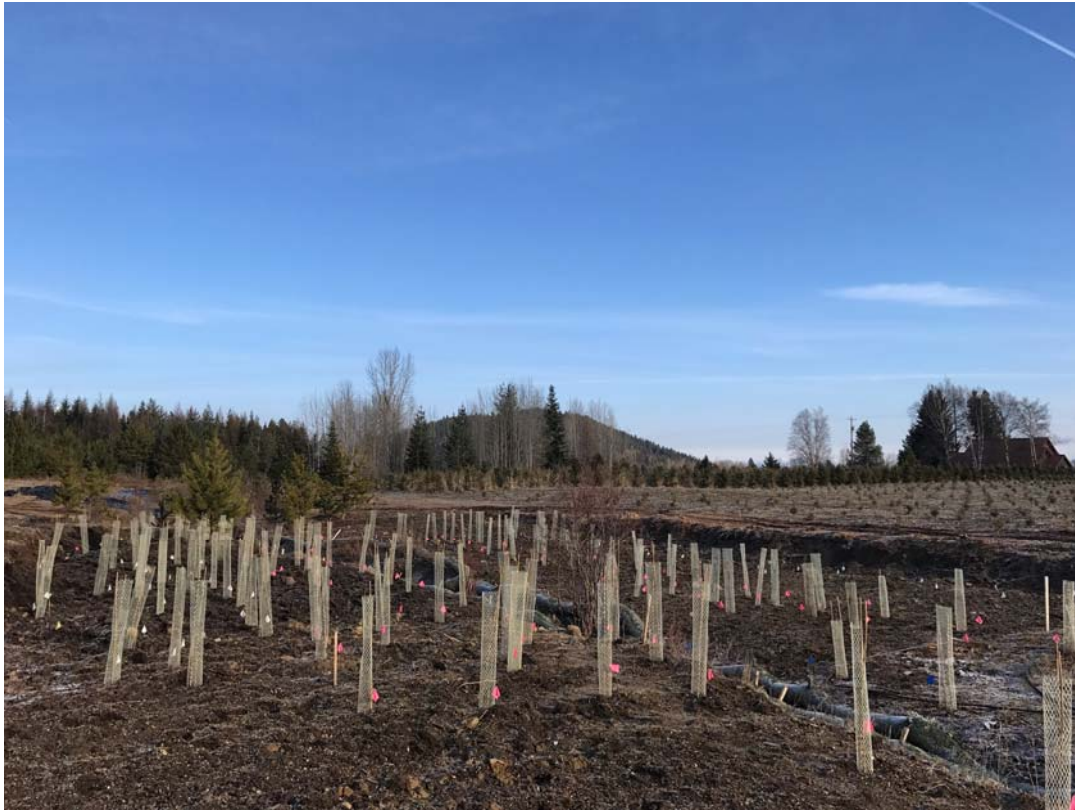
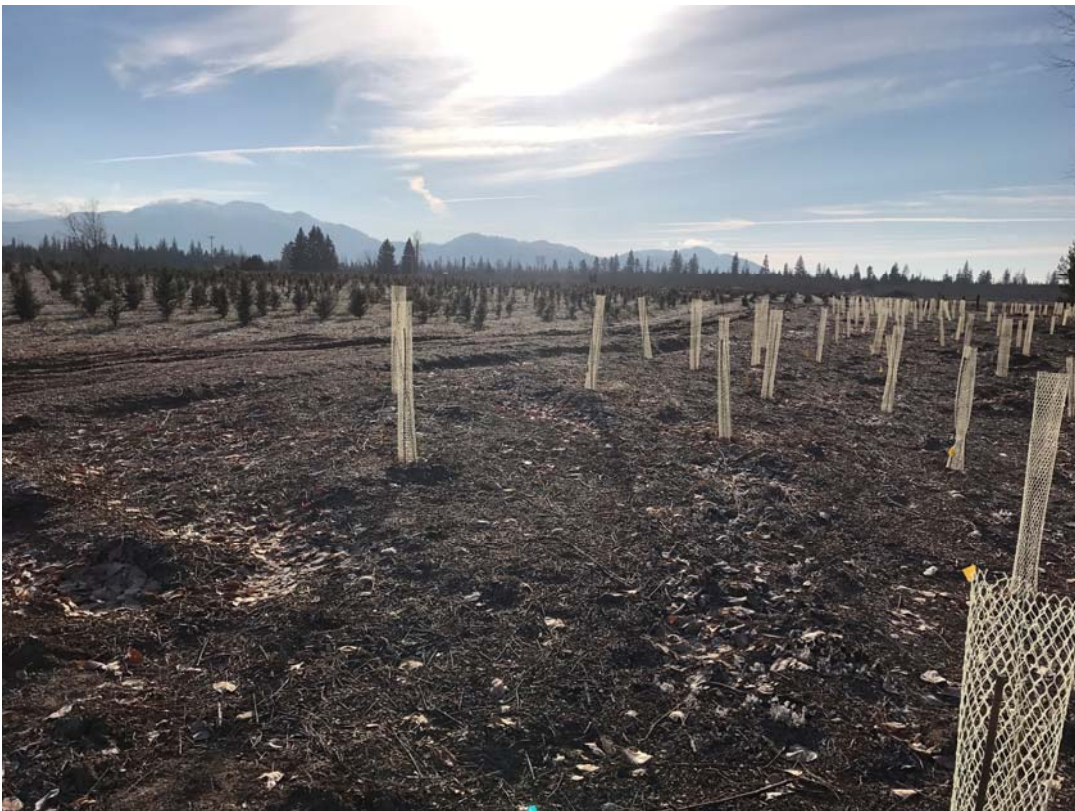
Figure B-4a. Looking northeast at the 2017-graded area post-planting (top) and south from HW-2 (bottom).

Appendix B, Figure 4 contains planting photo-documentation and Appendix C contains a tally of all plants placed during 2017, as well as all plants placed during 2016 and 2017 and those plants to be placed in Spring 2018

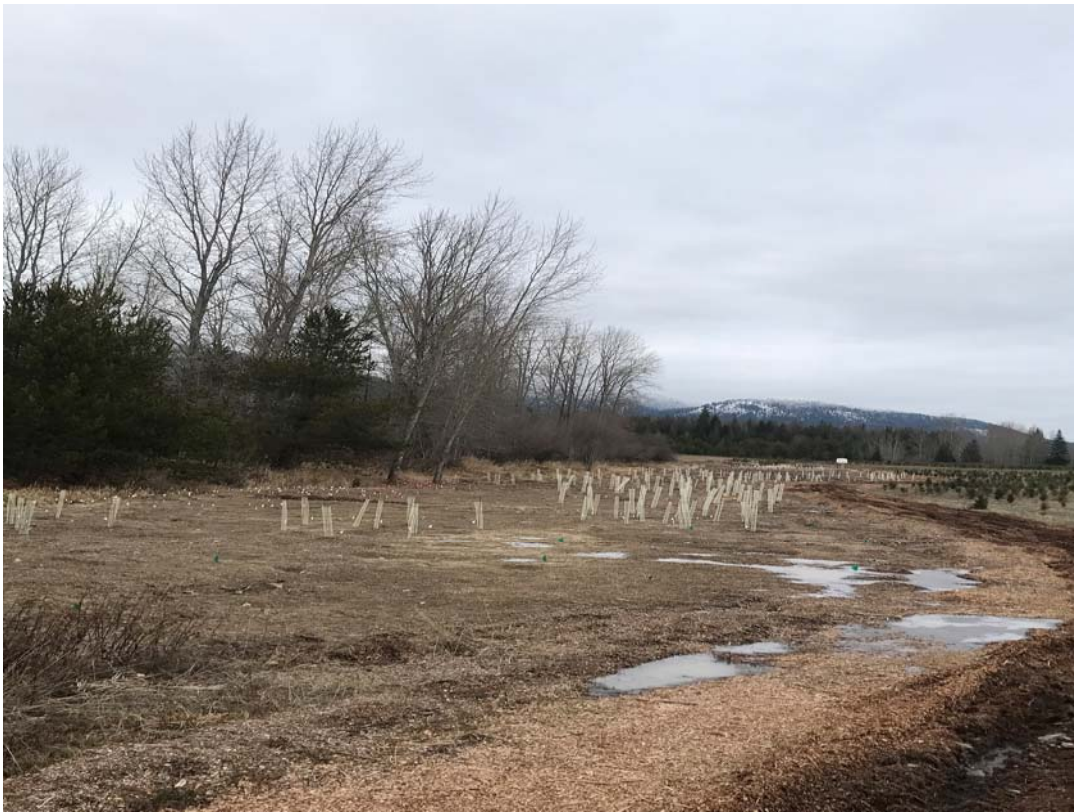
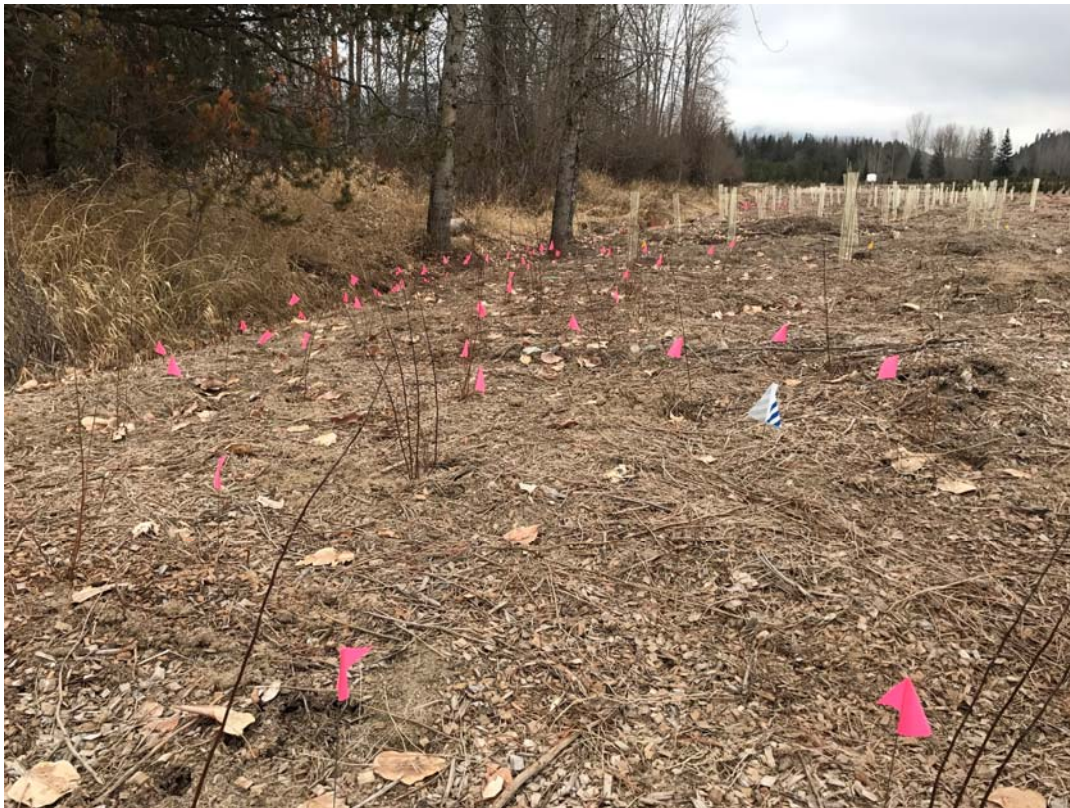
Figure B-4b. Looking north at the HW mitigation area from HW-3b. The close-up in the bottom photo shows the planted meadowsweet for which cages are still to be installed (pink flags) and flags for Bebbs willow (blue stripe) for which no plants were available Fall 2017.

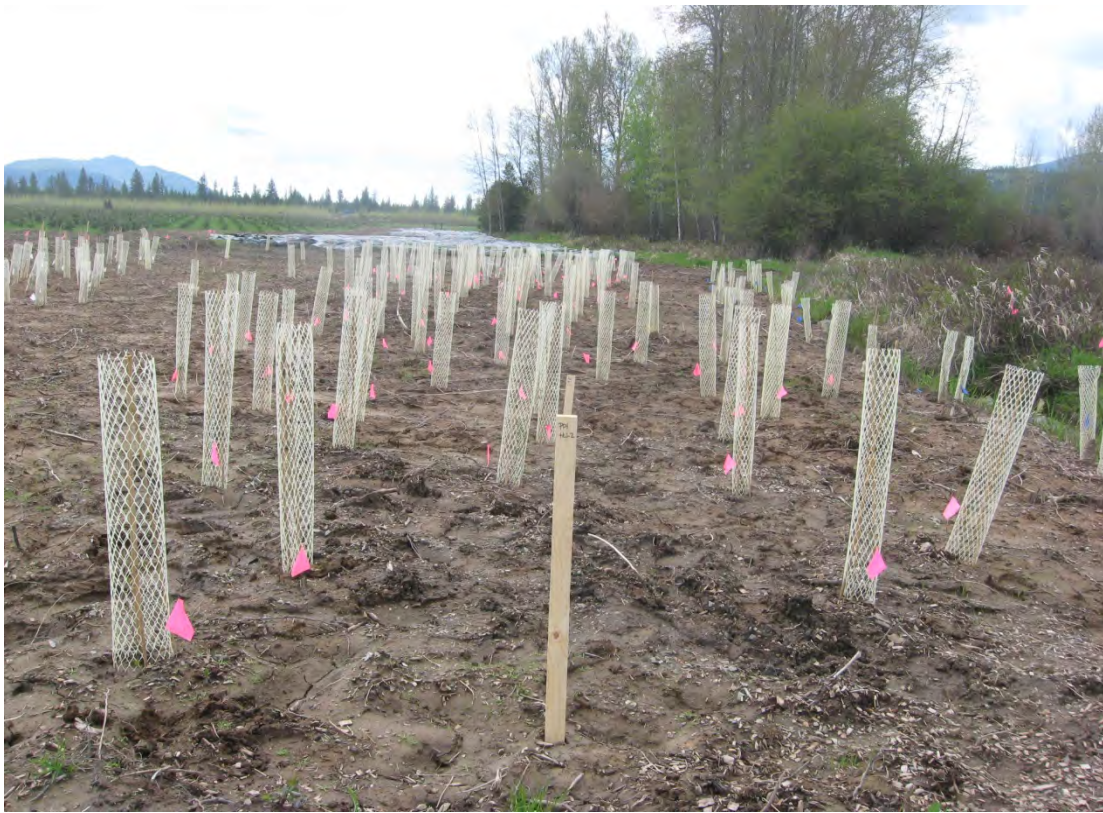
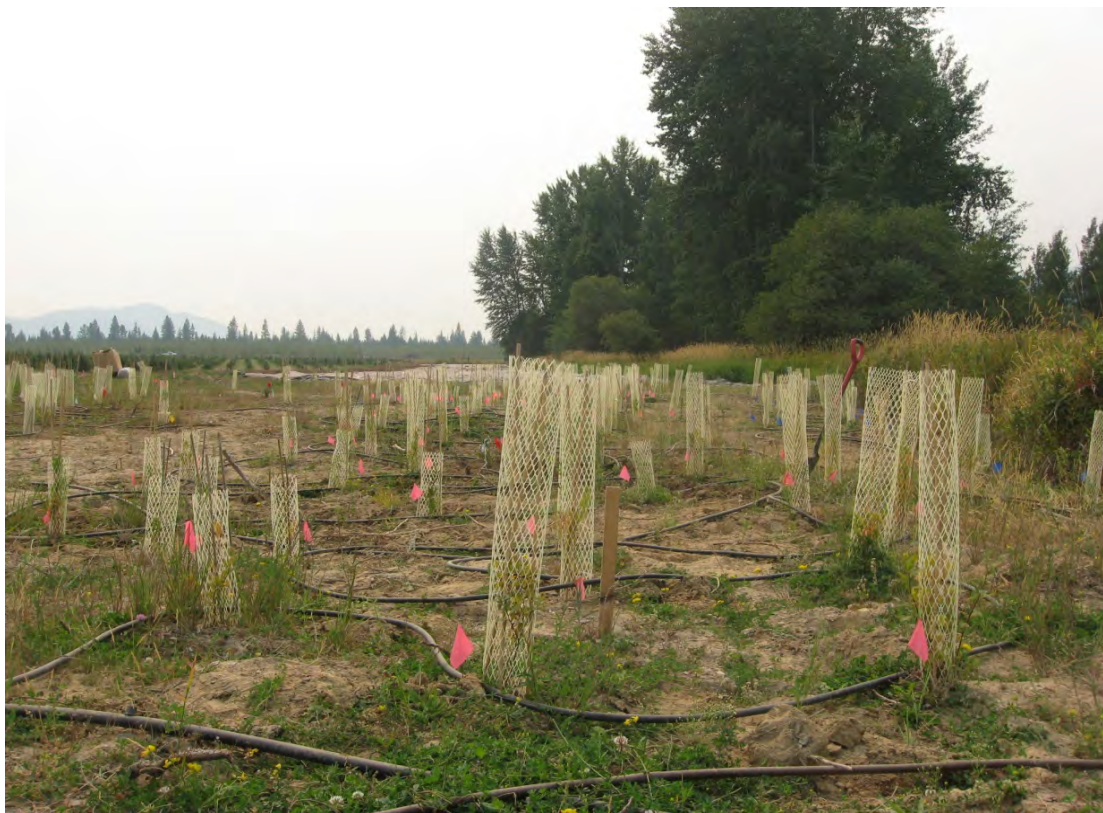
Figure D-2. HW-2 Photopoints (PP). PP 1 looking south from Transect 2 at the 2016-graded area in May 2017 (top) and August 2017 (bottom).

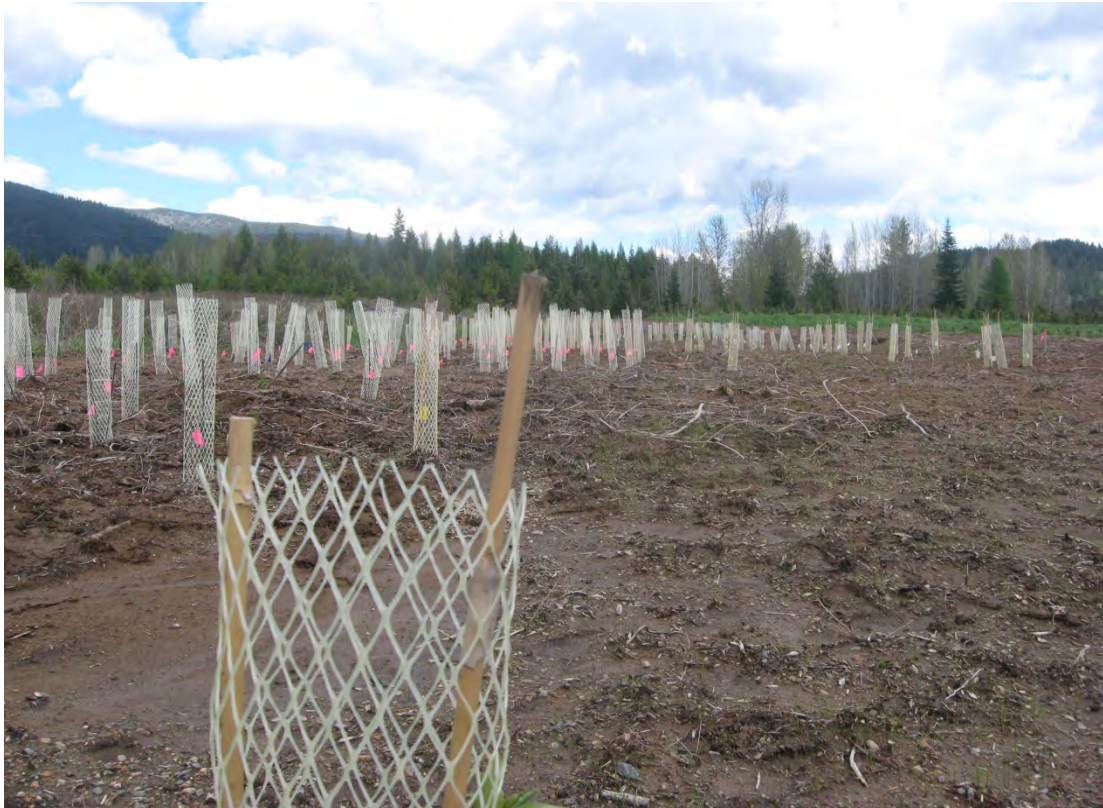
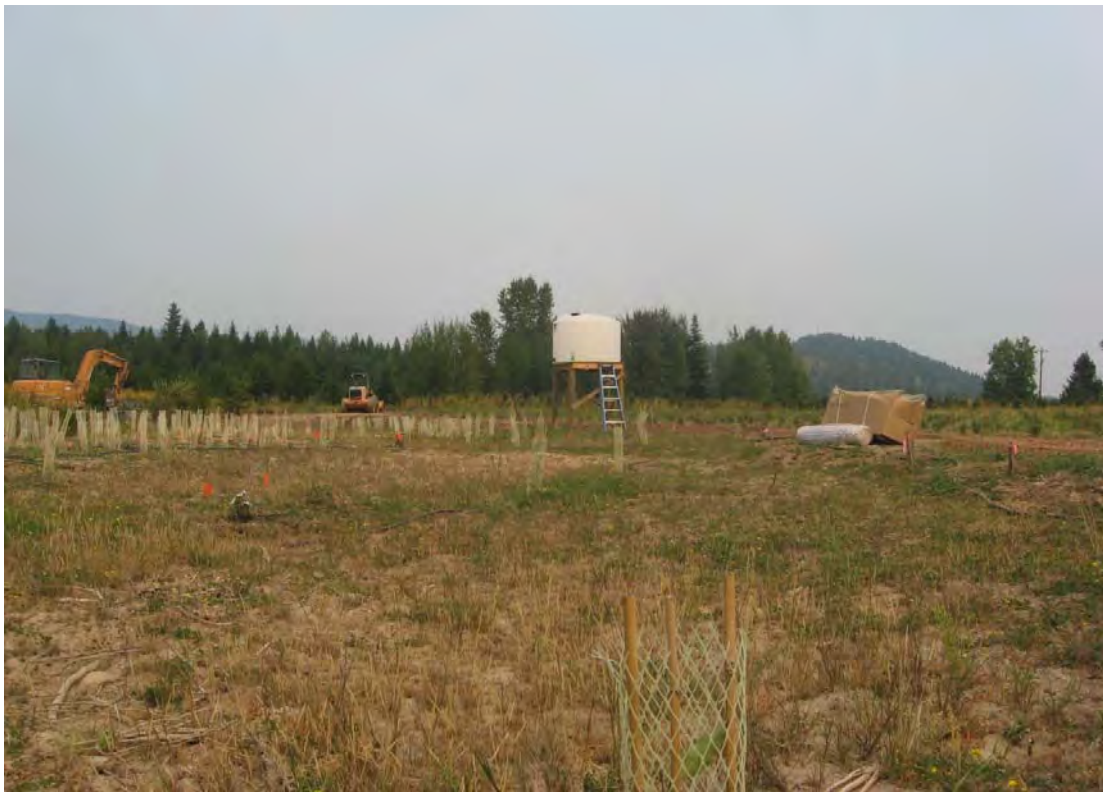
Figure D-3. HW-2 Photopoints (PP). PP 2 looking north at the 2016-graded area in May 2017 (top) and August 2017 (bottom, taken during the grading completion).

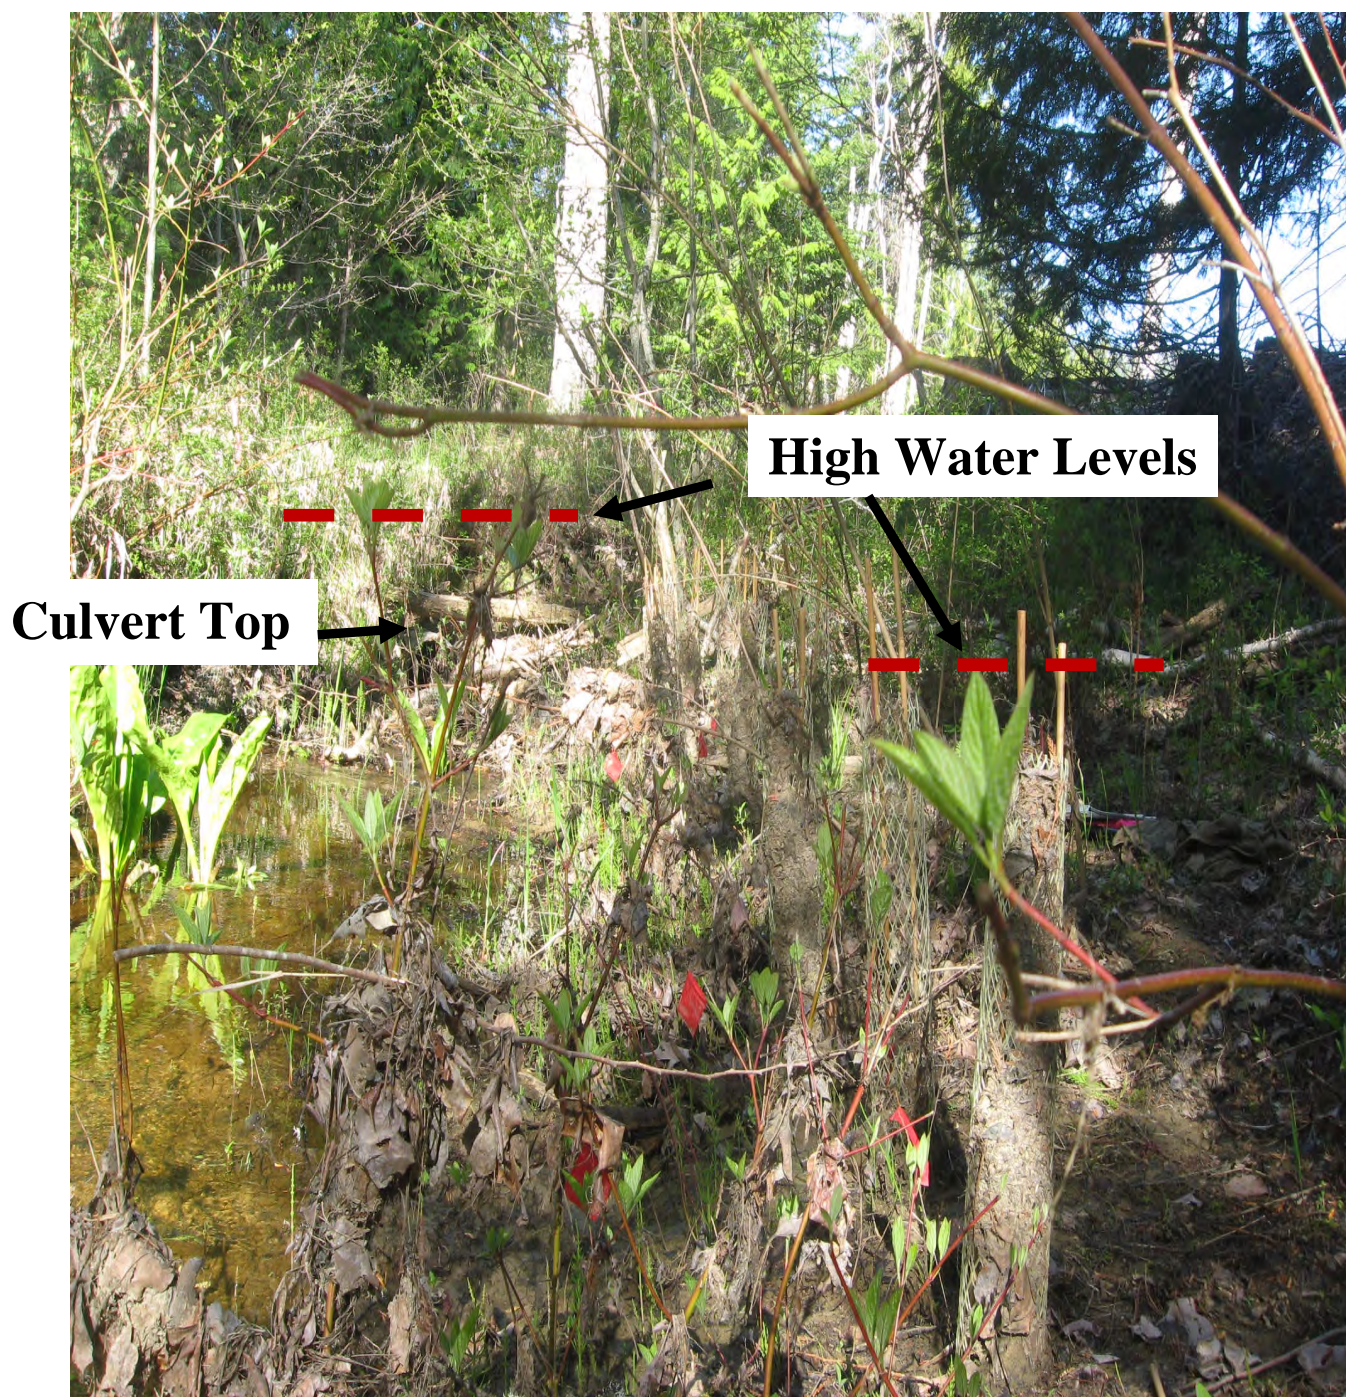
Figure D-5. 2017 High water level at the Culvert Enhancement area, as taken from Culvert PP 3 (looking southwest) in May 2017. Note a former anti-herbivory cage bamboo stake impaled in the soil at the high water level near the culvert.

Precipitation during the 2017 water year from October through April was almost double the long term average for the area (see Appendix A), with a number of rain-on-snow events. These conditions resulted in some periods of very high reservoir outflow and higher than usual flows in the unnamed tributary. Fourteen of the 114 planted trees and shrubs in the Culvert area were either removed by the flood flows or affected by flood-associated herbivory (i.e., herbivory where flows removed the protective cages) for an overwinter survival rate of 87.7%. Spring vigor was good where the cages remained intact, but only fair where cages were removed. High levels of ungulate browse were observed where plants were uncaged between the flood flows and early May when re-caging occurred.

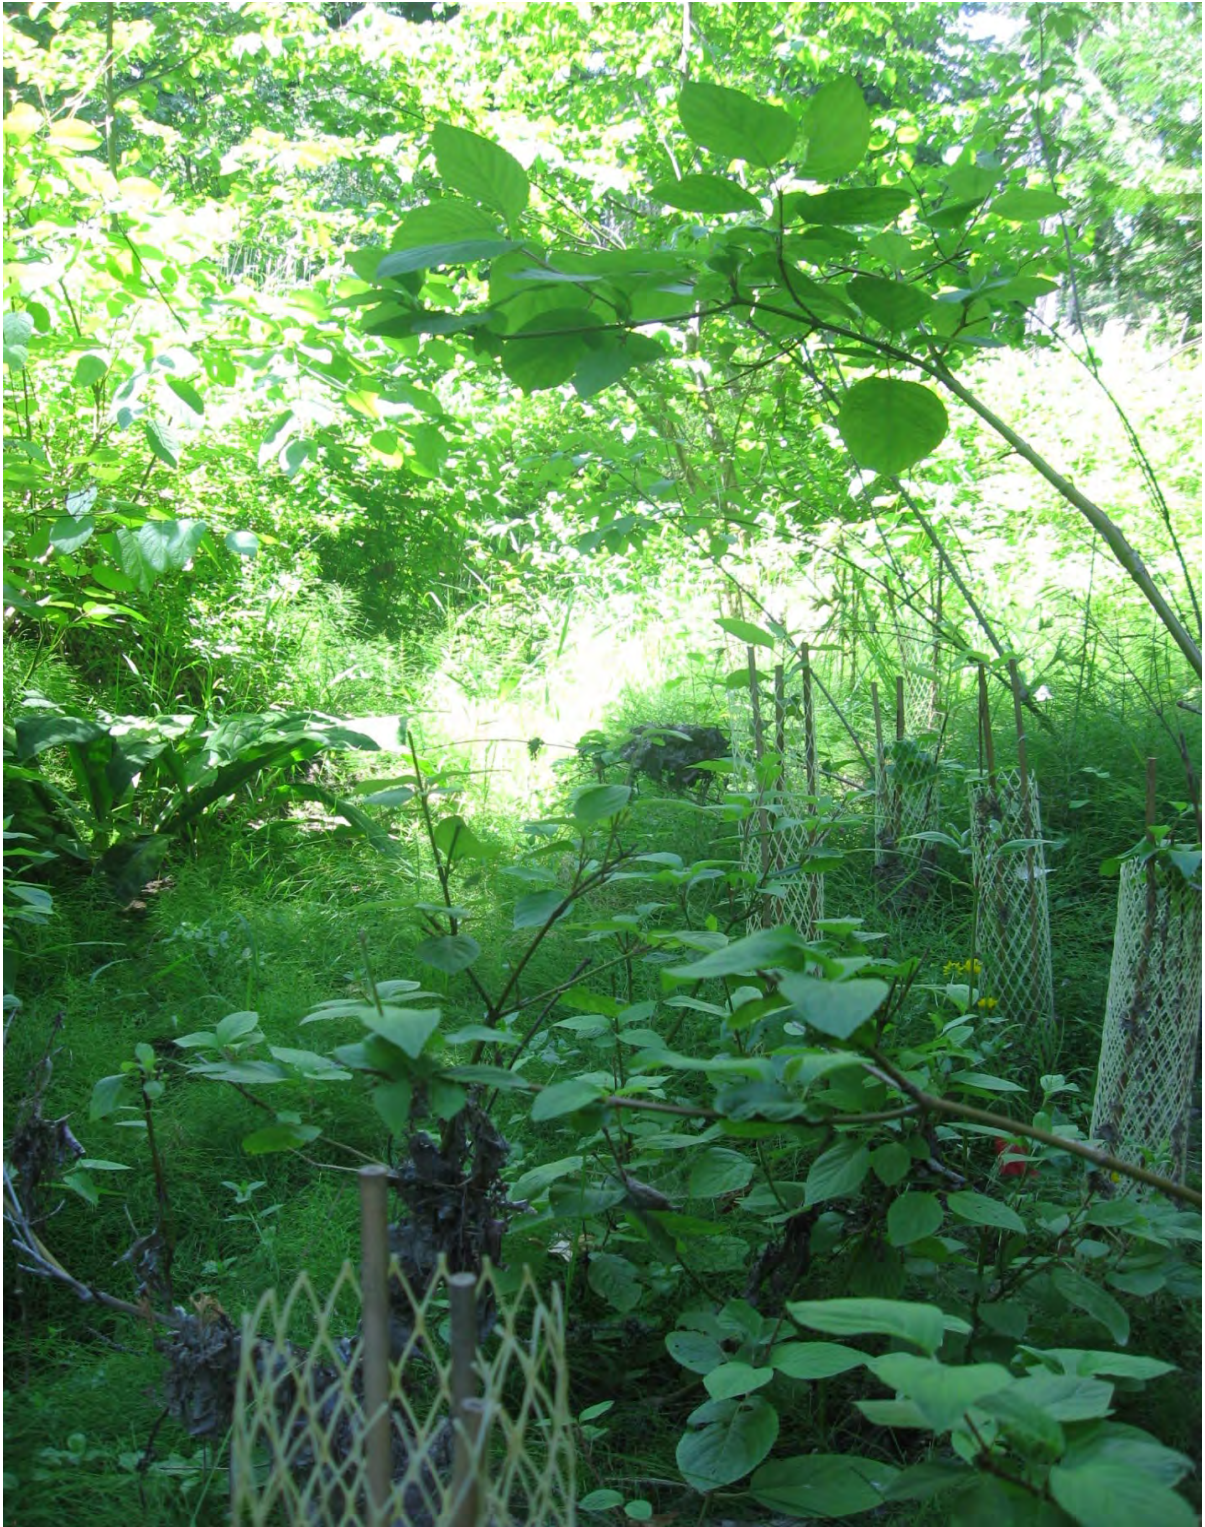
Figure D-5b. Looking southwest from PP3 in August 2017.

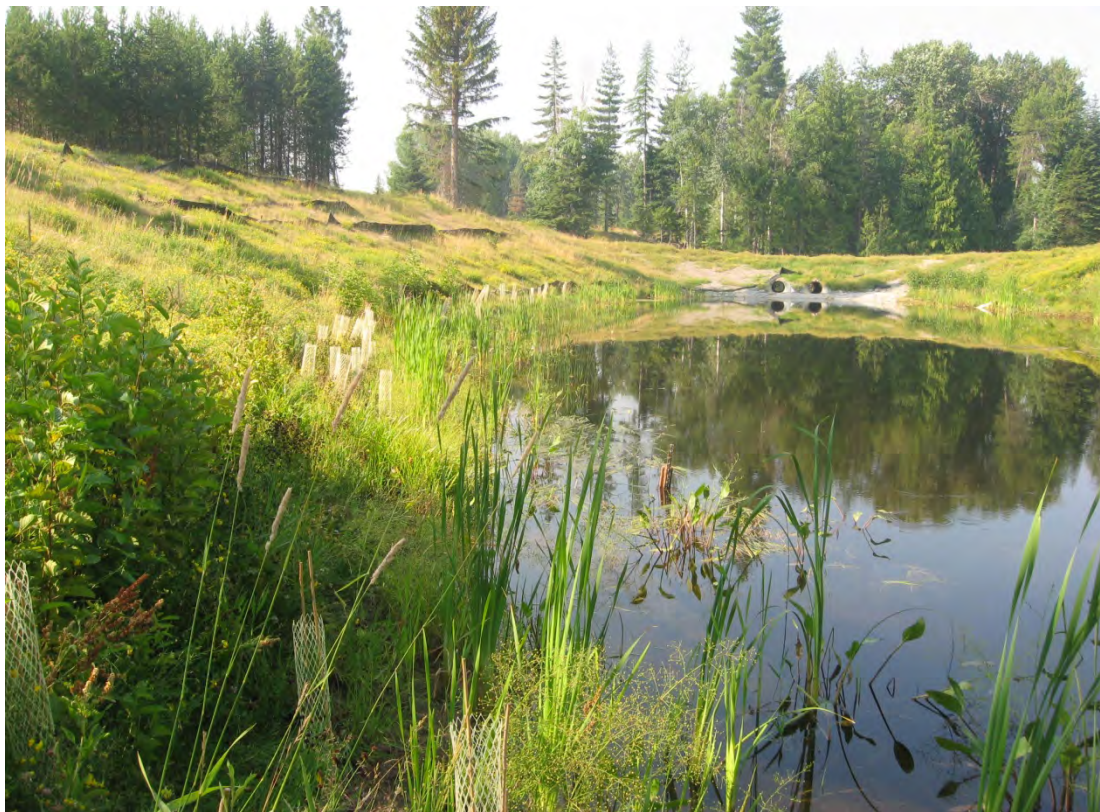
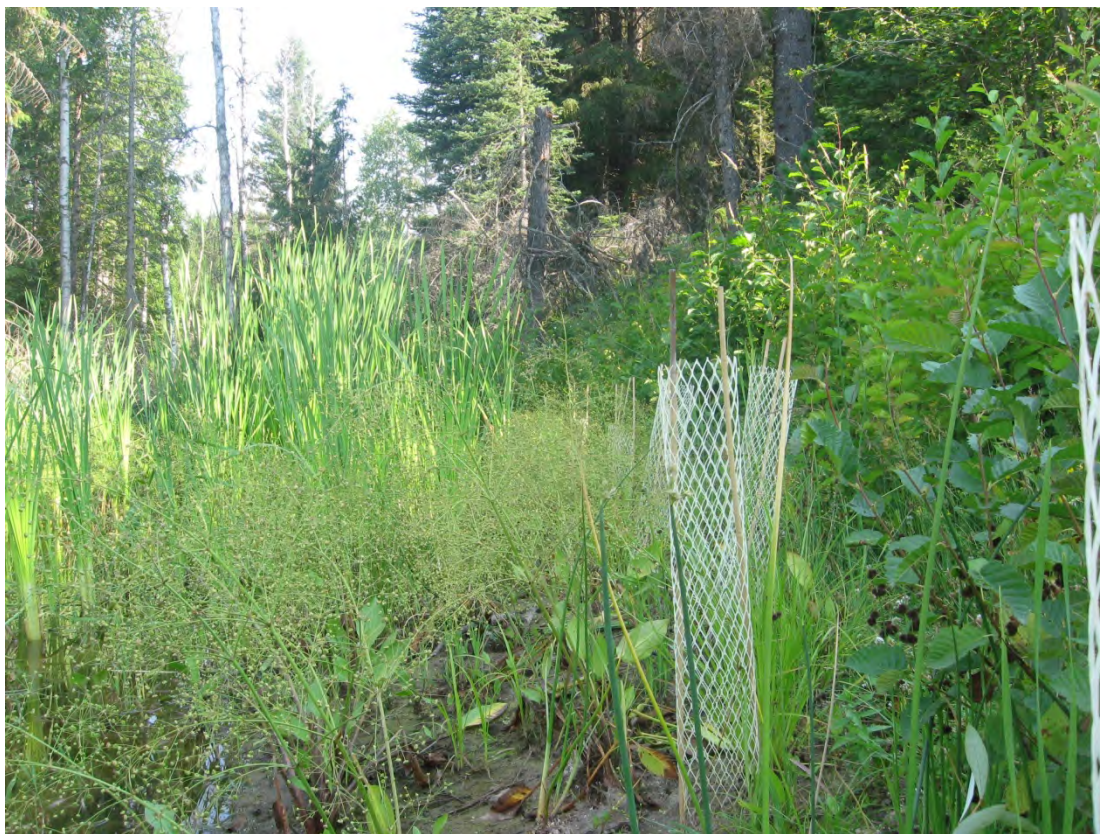
Figure D-7. Reservoir PP5 looking south (top) and north (bottom) in July 2017.

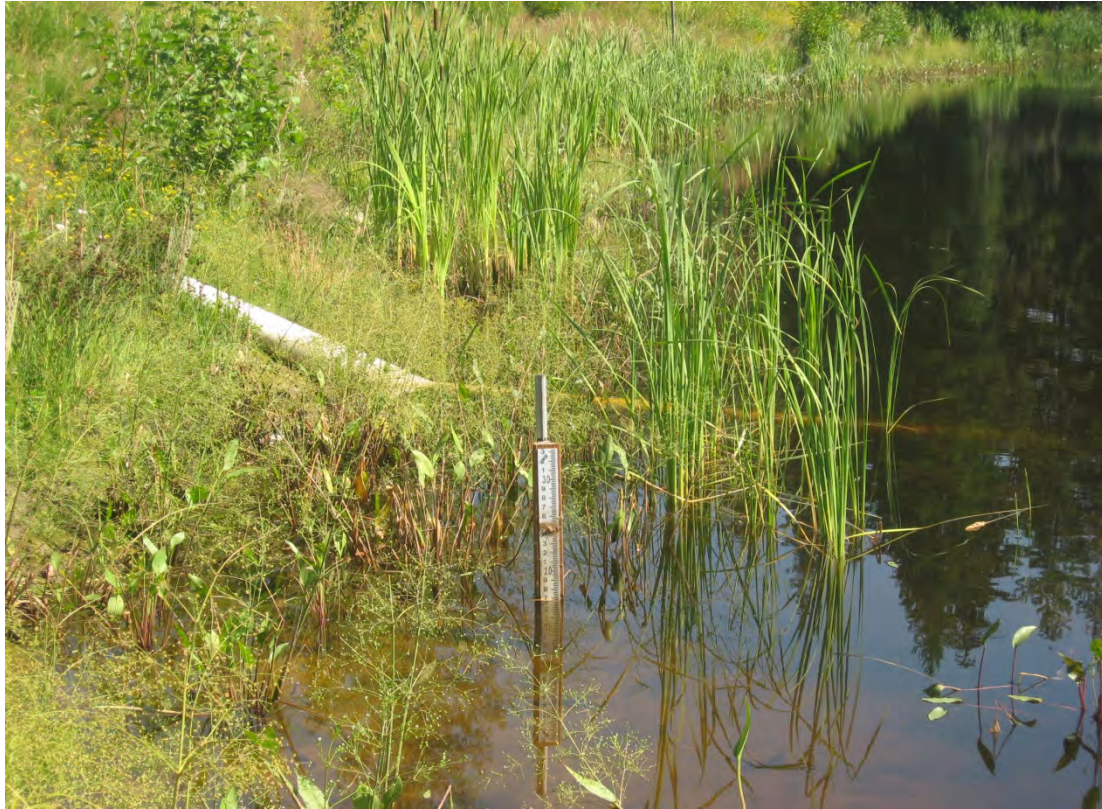
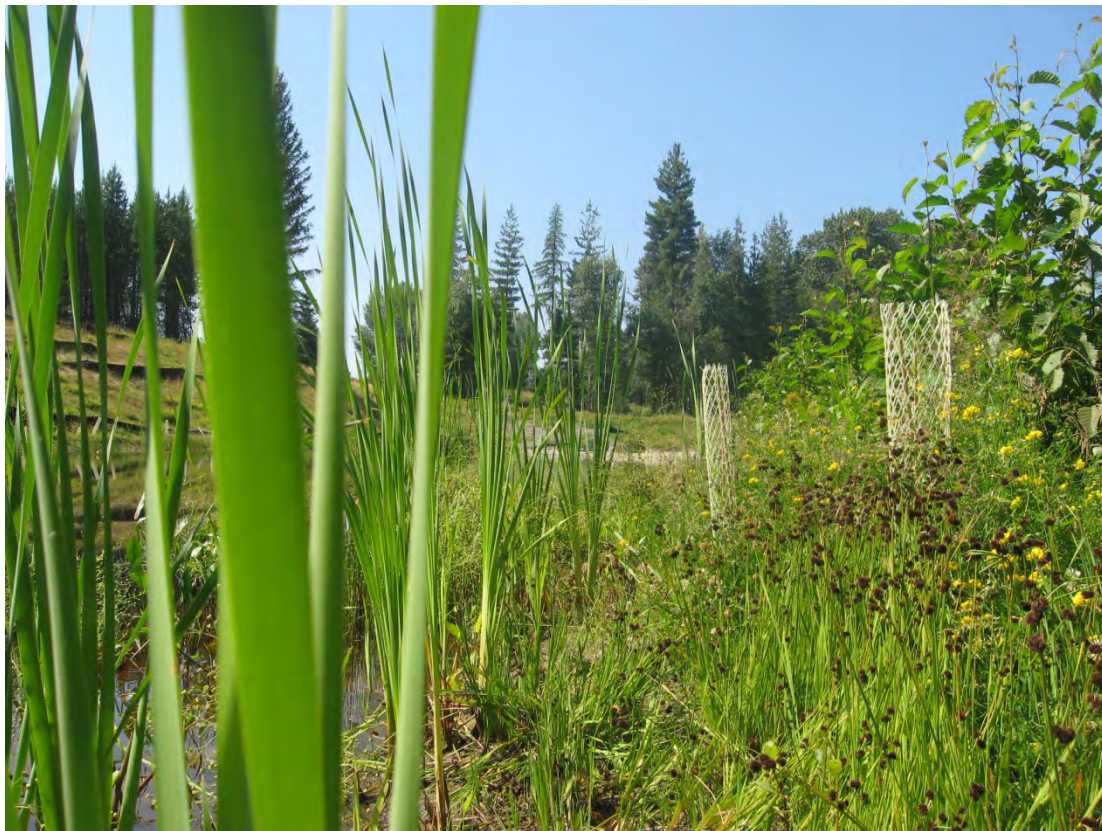
Figure D-8. Looking north at the lower gage/PP 7 (top) and from Reservoir PP6 looking south (bottom) in July 2017.
